Deterioration mechanisms of historic cement renders and concrete

Isobel Griffin. MA (Hons)

A thesis submitted to the University of Edinburgh
for the Degree of Doctor of Philosophy

July 2013

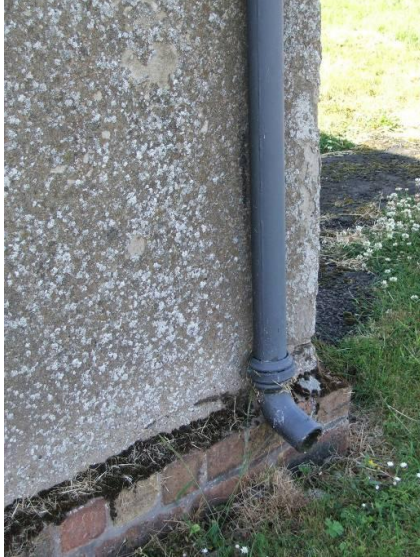
Fig. 3.14. Downpipe on Building 26 discharging directly onto the ground

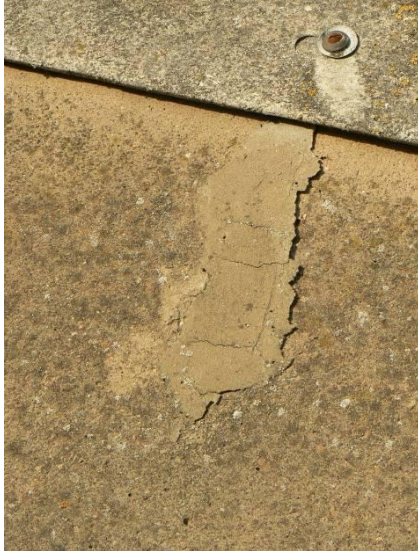
Fig. 3.18. Early repair over a ferrous tie on the gable end of Building 22, now cracking

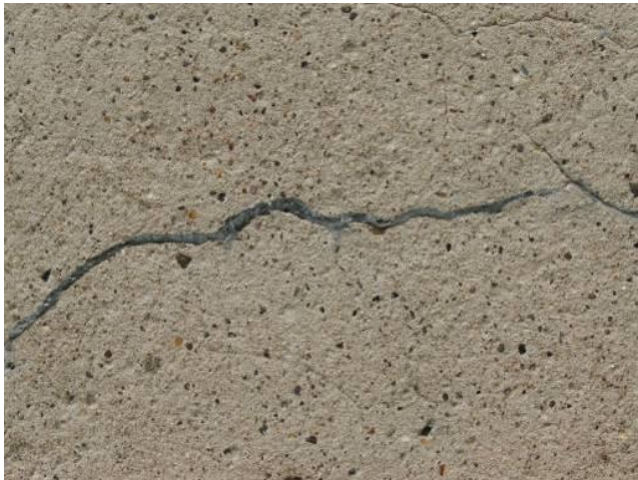
Early render repairs were generally roughly executed in cementitious mortar, and the crack fills often extend over the sound render on either side of the crack. The colour matching of the repairs is variable, but lichen growth has ensured that they now appear in reasonable harmony with the original render, and their performance otherwise has been good, although it is of course possible that some repairs have failed and been replaced. However, repairs to areas where the cement render is particularly prone to cracking, such as the corners of the window recesses and areas over the metal fixings, have often cracked again (Fig. 3.18). Some of the finer cracks have been filled with a dark grey material with a resinous appearance, and although this is quite unsightly, it has performed well and not cracked (Fig. 3.19).

Fig. 3.19. Dark grey resinous material used for some early crack fills, Building 25, E bay, S elevation

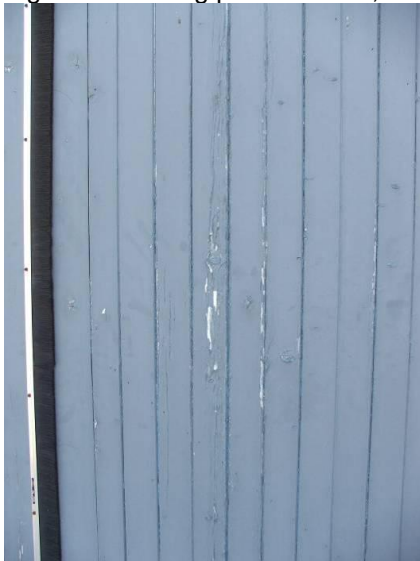
Fig. 3.20. Flaking paint on door, Building 25, W elevation

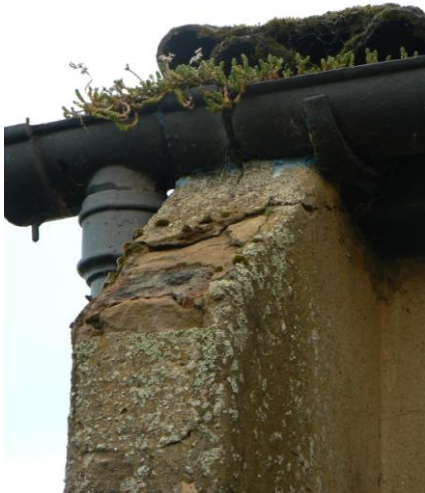
Fig. 3.21. Gutter blocked by plants, with damaged render on the pier head directly below, Building 26, W elevation

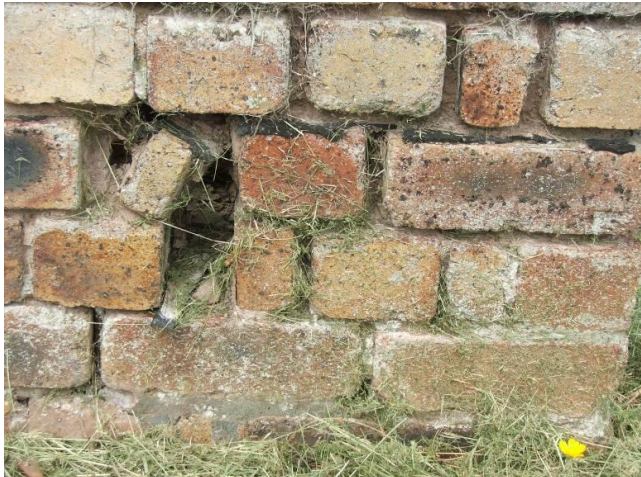
Fig. 3.22. Lack of pointing between bricks on Building 25, free-standing wall extending out from the E elevation

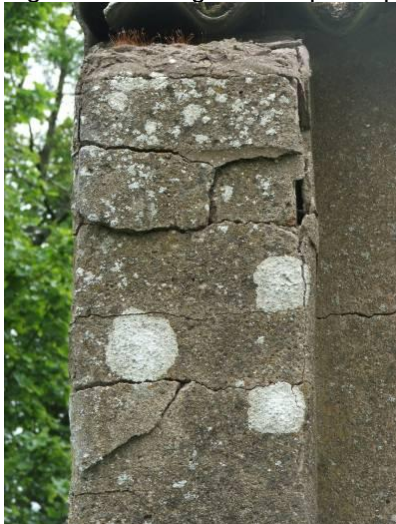
The main type of deterioration of the cement render was cracking (Fig. 4.1 and Figs. A1.1-A1.3). The cracks had provided a place for mosses and other plants to grow and the delamination of pieces of render had eventually occurred, usually at the interface between the render and the brick. In some instances the exposed brick was sound, but elsewhere the render had pulled off the surface of the brick and the brick itself had cracked. The areas worst affected were the piers, particularly along their sloping edges, the skews underneath the windows and the render at the base of the walls, and

Fig.4.1. Cracking at the top of a pier on Building 47

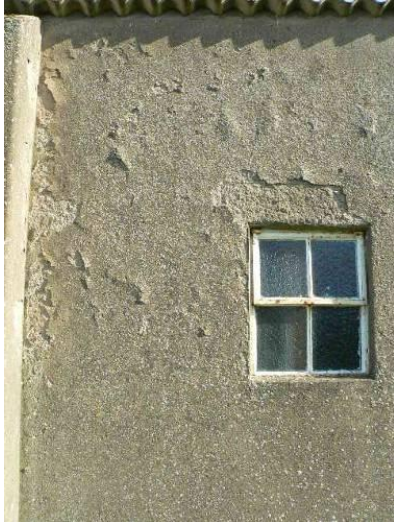
The render also deteriorated by blistering and flaking (Fig. 4.2), although this was only observed on some of the buildings, namely Buildings 22, 25, 26, 32, 44, 46 and 47. It occurred primarily, but not exclusively, on the south elevations. Small raised blisters were formed, which either detached individually or joined together causing the render surface to flake off in large sheets. Other damage to the render included mechanical damage resulting from accidental knocks and deliberate alterations to the buildings (Figs. A1.4-1.5). For example, the three evenly spaced areas of lost render on Building 34 probably corresponded to something having been fixed to the building previously.

Fig. 4.2. Blistering and flaking render on Building 46

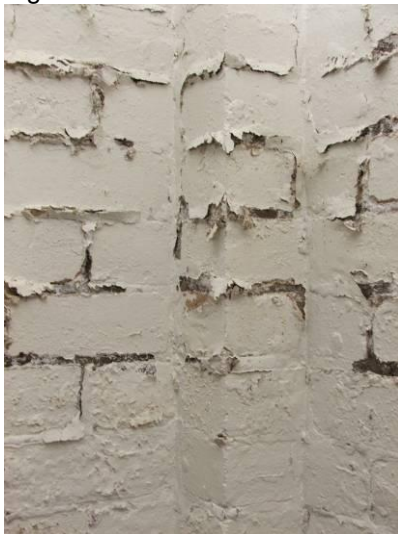
The main types of deterioration observed inside the buildings were staining of the internal ceiling panels, most probably due to water infiltration, and salt efflorescences on the bricks and mortar joints, causing disruption of internal paint where it had been applied. The salt efflorescences were most obvious in Building 25, particularly in the rooms with heating and/or dehumidification, and in Building 37, which was extremely well ventilated because the large external doors were frequently propped open. The efflorescences were concentrated along the mortar joints, although they were also visible on the bricks (Fig. 4.3).

Fig.4.3. Salt efflorescences on the internal wall of a heated room in Building 25

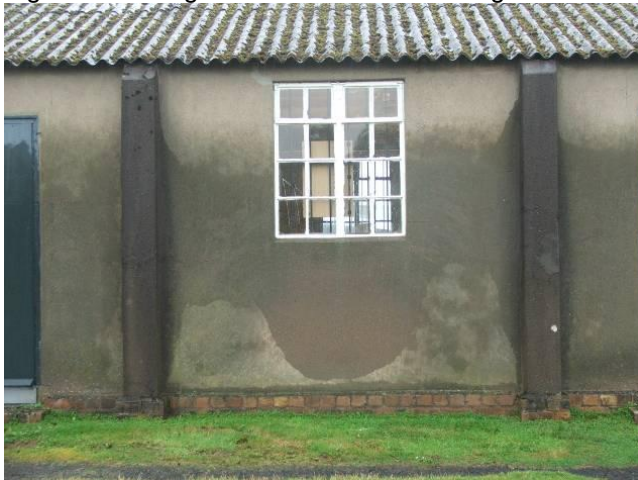
Fig. 4.5. Wetting due to rainfall on Building 32

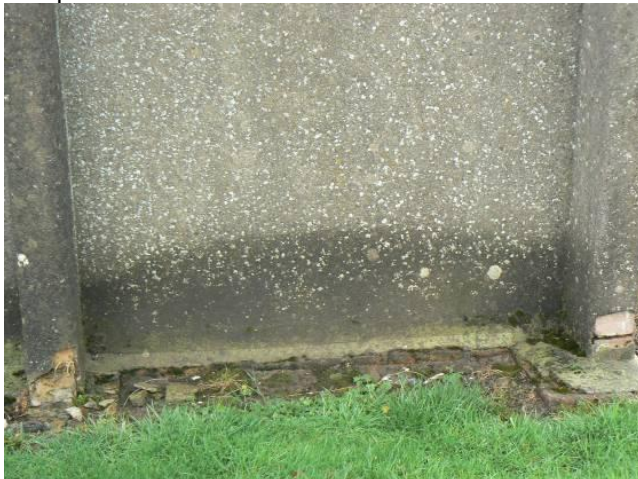
buildings even on dry days (Fig. 4.6). Where gutters were present they provided some protection for the upper walls and appeared to reduce the amount of water collecting on the ground, and hence the wetting of the base of the walls due to rising damp and splash back. The gravel-filled drainage channels around the repaired buildings seemed to assist with water disposal, but where there was gravel alongside the unrepaired buildings it was compacted into the ground rather than present in drainage channels, and may have hindered rainwater absorption by creating an impermeable surface.

Fig. 4.6. Darkened zone along the base of the walls on Building 24, possibly caused by rising damp

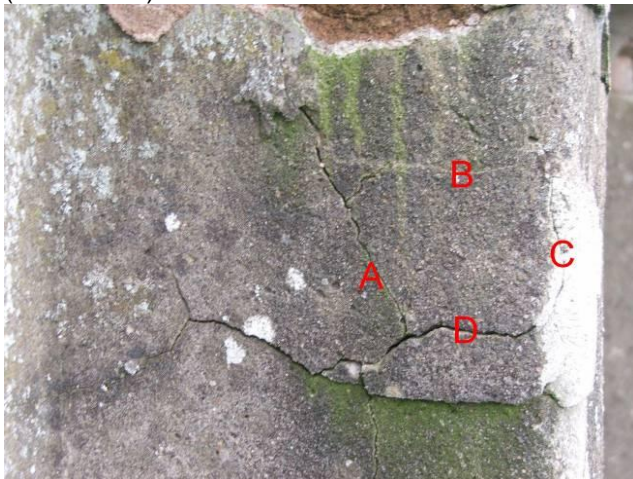
Photographs on a larger scale show how cracks develop and eventually lead to render delamination. From Figs. 4.8 and 4.9 of the third pier from south west on the north west elevation of Building 32 it can be seen that the cracks visible at A, B, C and D in October 2010 bordered the piece of render which was lost by February 2011. Fig. 4.9 also shows the existence of fine cracks at E, F and G which were

Fig. 4.8. Building 32, cracking render on the third pier from SW on the NW elevation (13/10/2010)

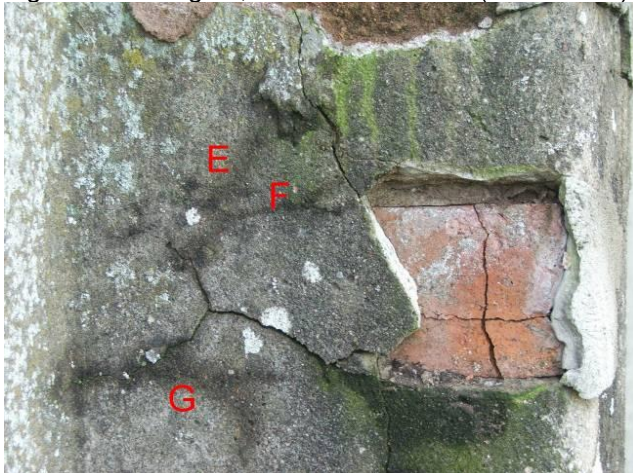
Fig. 4.9. Building 32, area of lost render (02/02/2011)

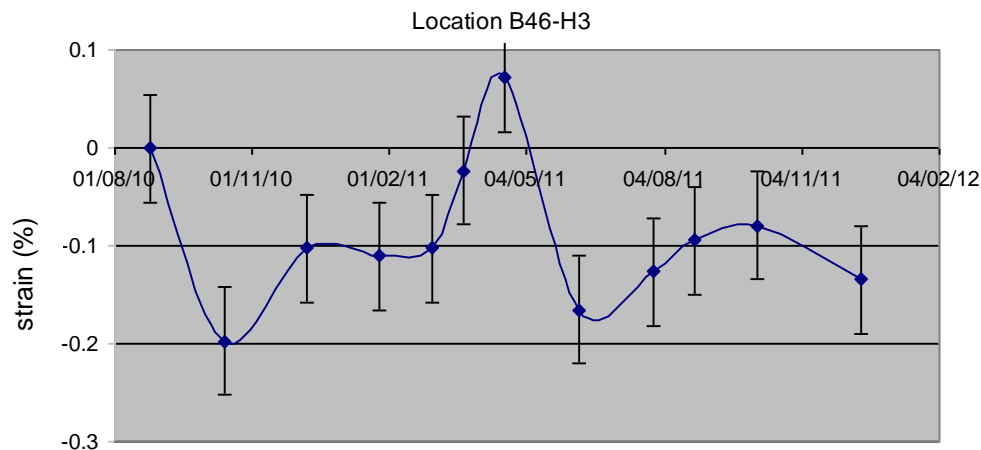
The monitoring of the un-cracked render on Building 46 suggested that the strain between the datum points varied by a maximum of 0.48% over the course of an 18-month period (Fig. 4.11 and Figs. A.41-A.45). It was not possible to see a seasonal trend in the results, and there was no obvious difference between the south east and north west elevations. The variations were presumably due to some combination of thermal movement, movement due to water absorption and movement due to freeze-thaw cycles. More accurate linear variable displacement transducer (LVDT) measurements for the movement of un-cracked render are given in Chapter 8.

Fig. 4.11. Graph showing the strain measurement across the un-cracked render on Building 46, where the strain between datum points varied by a maximum of 0.27%

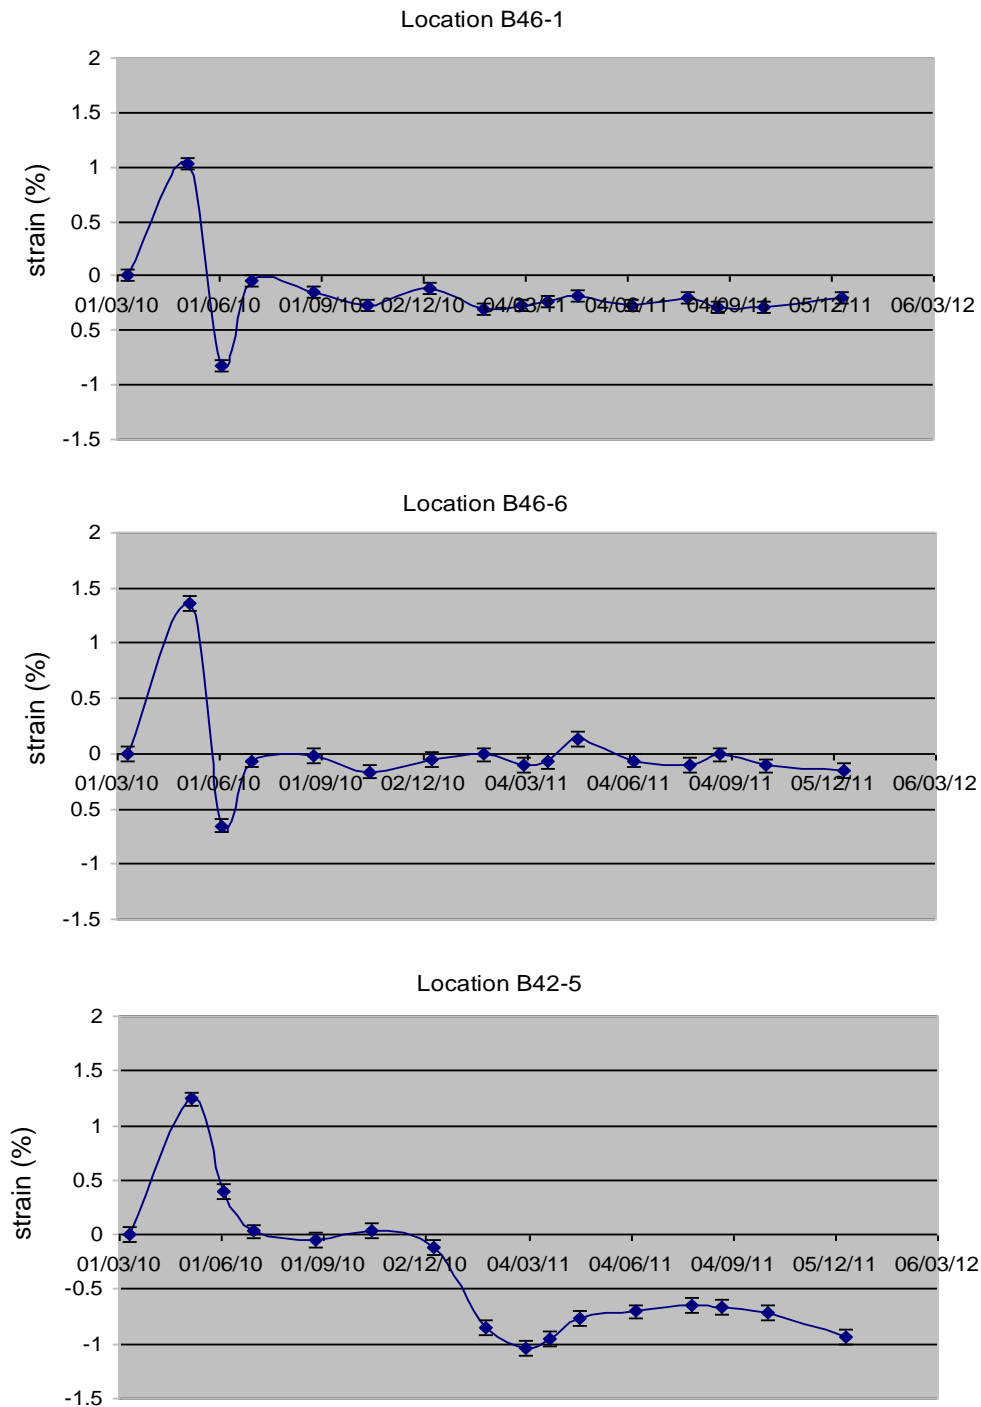
Many of the strains between the datum points on the cracked render were below 0.48%, suggesting that they could simply have been due to render movement as measured on Building 46, and possibly caused by environmental changes. However, strains of up to 1.36% were also measured, which presumably were partially due to crack movement. The strains were not consistently higher in December 2012 than in March 2010, suggesting that although the cracks around the windows and doors were moving, they were not necessarily getting wider.

Fig. 4.12. Strain measurement across the cracking on Buildings 42 and 46, showing some similarities

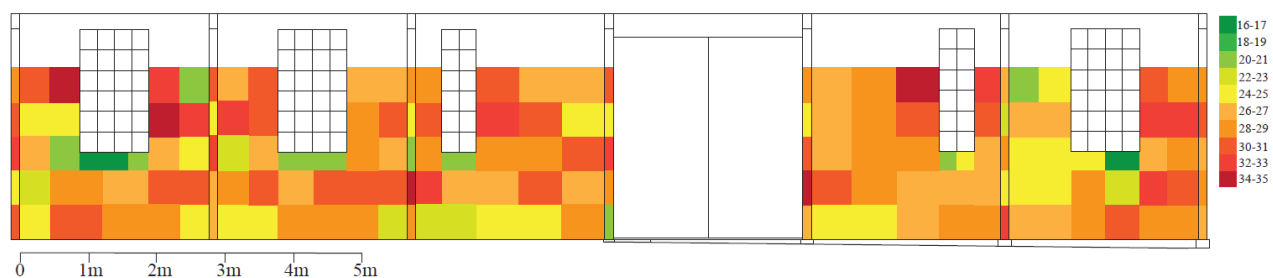
The results for the air raid shelter are discussed in Chapter 11. The readings obtained with the rebound hammer on Building 47 varied from 16 to 34, averaging about 26 (Fig. 4.13). In general, the readings showed some correlation with the visual appearance of the render: smooth, well-compacted render gave high readings, and cracked or poorly compacted render gave lower readings. However, the readings were not lower in the areas where the surface of the render had flaked off, suggesting that the flaking had not affected the cohesion of the render below the surface. The readings were generally lower immediately below the windows and close to the ground, and these are areas which might be expected to be in poorer condition due to frequent wetting. However, lower readings were not obtained on the piers, which were also wet frequently. This suggests that the degree of weathering influenced by the render does not necessarily affect its hardness.

Fig. 4.13. Building 47, SW wall, rebound hammer readings

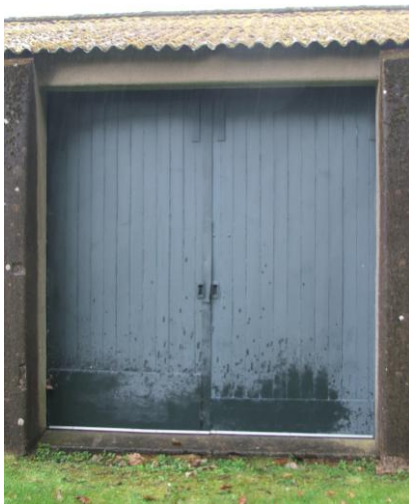
Fig. 4.15. Evidence of splash back on the door on the W elevation of Building 47

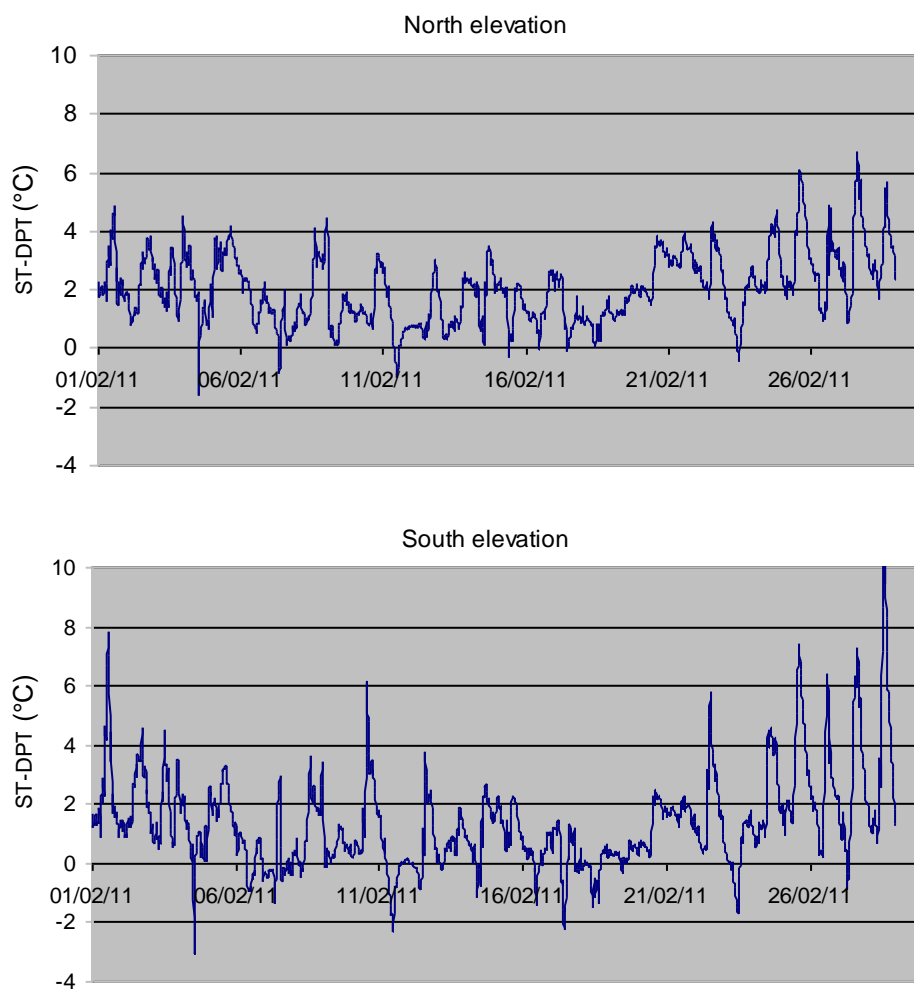
The surface temperature monitoring showed that condensation was likely to have occurred fairly frequently on both the north and south elevations of Building 26. There were generally more instances of potential condensation in the winter than in the summer, and more instances on the south elevation than on the north (Fig. 4.20). This was because the surface temperature was more variable and reached lower values on the south elevation.

Fig. 4.20. Graphs of surface temperature minus dew point temperature for February 2011, showing the likelihood of condensation events whenever $ST-DPT \leq 0$

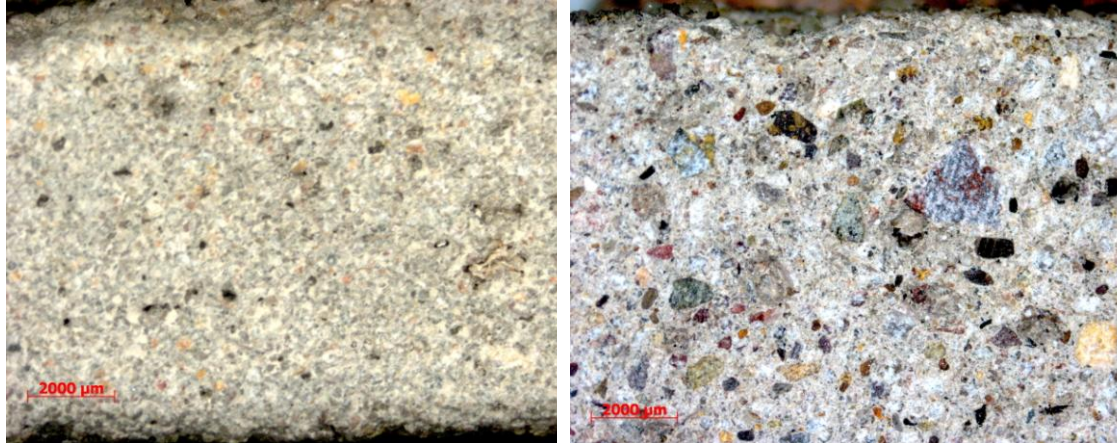
The aggregate in B24 OR and B23 RR was predominantly fine quartz, with a maximum particle size of 0.5 mm, whereas the aggregate in the other renders had a wider particle size distribution and was a mixture of quartz and other minerals (Fig. 5.1). In particular, the brown, grey, pink and orange particles measuring up to 4 mm in B47 OR gave it the appearance of concrete. The size and distribution of the air voids appeared to relate to the particle size distribution of the aggregates: B24 OR and B23 RR contained frequent air voids measuring below 1 mm, whereas the air voids in B32 OR, B47 OR and B25 RR were fewer in number but larger, measuring up to 3.5 mm.

Fig. 5.1. Differing composition of the original renders viewed in section: B24 OR on the left and B47 OR on the right

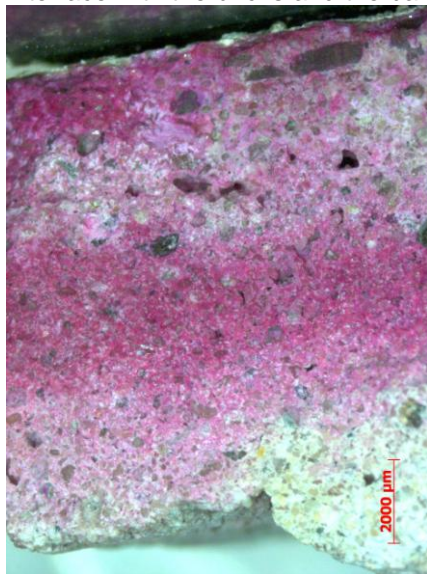
as a consequence of the voids at the interface (Fig. 5.2). These voids suggested that the bonds between the layers might be poor, and were the only evidence of poor workmanship in the renders.

Fig. 5.2. Staining of B25 RR with phenolphthalein, showing carbonation of the surface, the interface with the bricks and the band along the interface between the layers

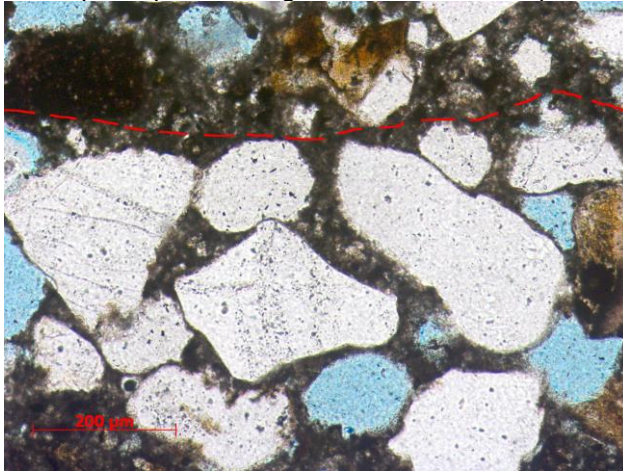
The original render from Building 24 (B24 OR) had been applied in two layers, with a cement-rich layer along the interface. The upper layer had probably been applied when the lower layer was still wet as the boundary was difficult to differentiate, and had been missed in the examination at low magnification. The render appeared fairly porous, with irregularly shaped entrapped air voids measuring up to 2000 μm (Fig. 5.4). There was a concentration of voids just below the surface, which had probably formed when the render was smoothed over as this process brings moisture to the surface.

Fig. 5.4. B24 OR, showing the join between the render layers and the presence of large voids, plane polarized light, field of view: 875 μm across

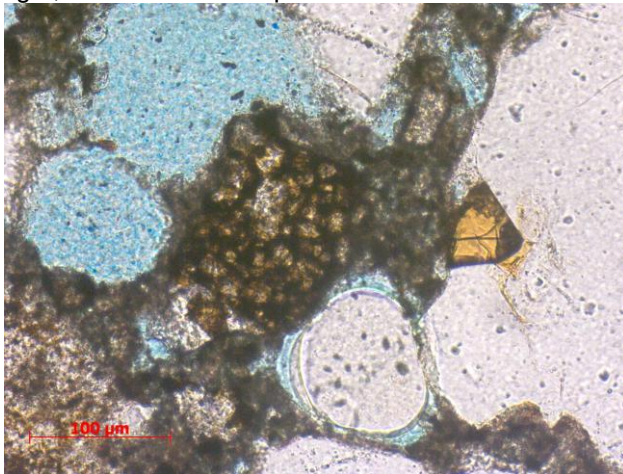
Occurring frequently within the cement matrix of B24 OR were small to medium-sized, dark brown, opaque areas of fully hydrated cement and medium-sized relict cement grains (Fig. 5.5), again indicating that the initial mix was dry. Medium

Fig. 5.5. Relict cement grain in B24 OR, seen in the centre of this image, plane polarized light, field of view: 440 μm across

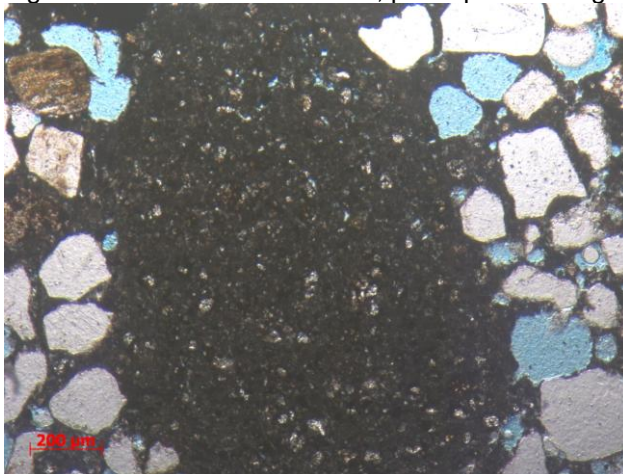
to large lumps of balled fines also occurred frequently (Fig. 5.6), consisting of particles of quartz and cement, bound together with silt and clay. They may have formed when the cement and slightly damp sand were mixed together, before the water was added. As found using phenolphthalein indicator, the cement matrix was quite well carbonated at the surface and the interface with the brick, but only partially carbonated in the middle.

Fig. 5.6. Balled fines in B24 OR, plane polarized light, field of view: 1750 μm across

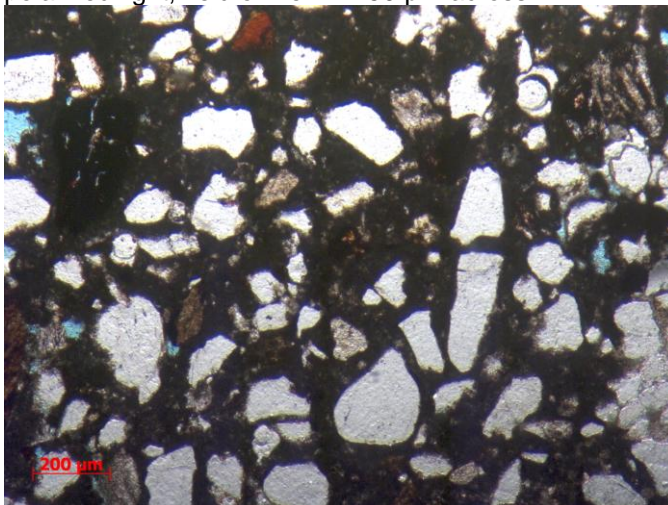
Despite the appearance of two layers in the examination of B32 OR at low magnification, only one layer was visible in the thin section. The render contained fewer voids than B24 OR (Fig. 5.9), but the presence of calcite and portlandite on the surface and in the voids suggested that the mix was wetter than the B24 OR mix. There were some micro cracks running perpendicular to the surface and parallel to the render-brick interface, which were probably caused by drying shrinkage (Fig. 5.10). Fine calcite crystals along the render-brick interface suggested that B32 OR had a good bond with the underlying bricks.

Fig. 5.9. Dense area of uncarbonated render from B32 OR with almost no voids, plane polarized light, field of view: 1750 μm across

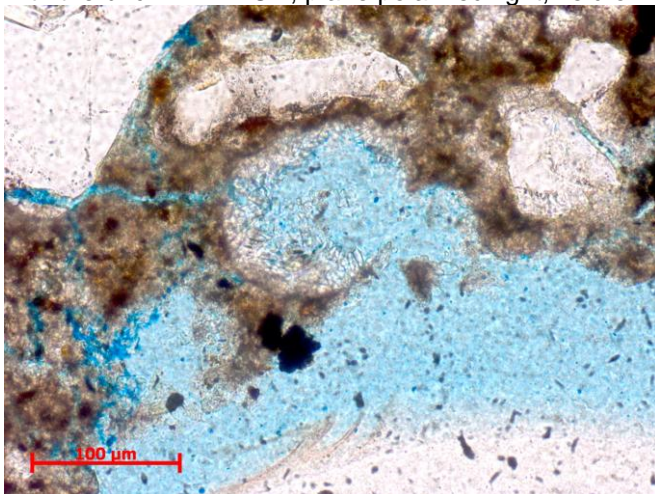
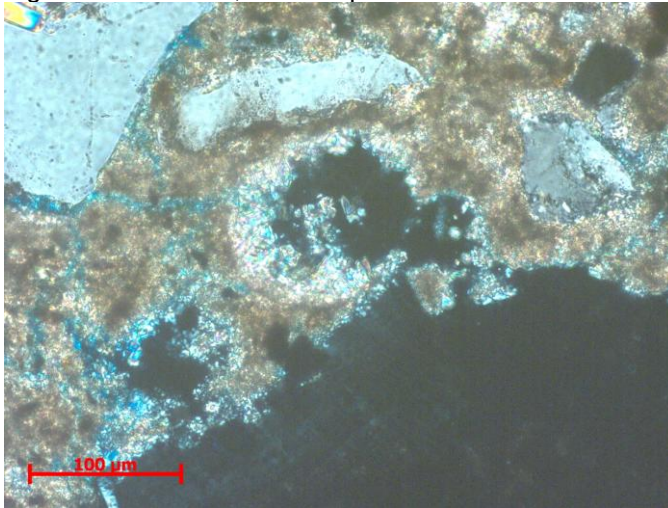
B47 OR was similar to B32 OR, but not identical. Again, there was only one layer visible in thin section and there were not many voids present. The surface had been smoothed down, resulting in a dense outer layer with some voids behind it. The presence of portlandite and calcite in the voids and around the aggregate particles suggested a wetter mix than for B24 OR, and there were again some micro cracks and fine cracks, probably due to drying shrinkage and possibly also resulting from the shrinkage or swelling of the layered mudstone particles. The bond with the brick appeared good, as there were no voids or cracking along the render-brick interface and the presence of calcite crystals suggested that moisture had been drawn from the render into the brick (Figs. 5.12-5.13).

Fig. 5.12. Carbonated cement matrix and infill minerals in the voids close to the interface with the brick in B47 OR, plane polarized light, field of view: 440 μm across

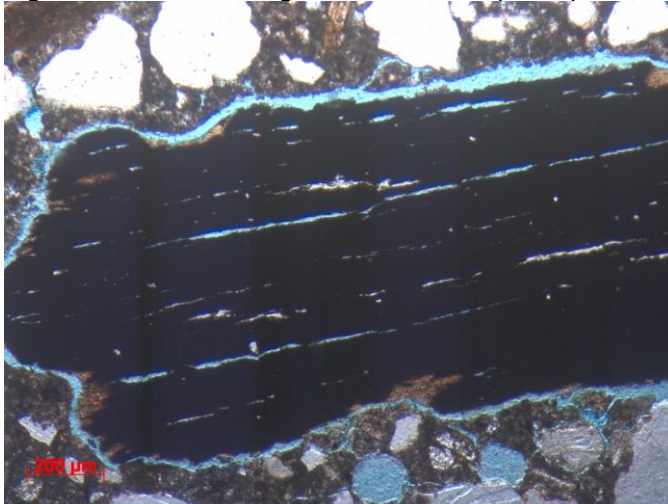
As in B32 OR, the aggregate in B47 OR was moderately sorted and was made of up two aggregate types: rounded rock fragments (Figs. 5.14 and 5.15) and angular quartz. This again suggested a deliberate addition of sharp quarry sand. The mixed rocks were similar to those found in B32 OR, and may have come from the same gravel pit, but the sand was coarser, with fewer than 25% by volume of the

Fig. 5.15. Mudstone fragment in B47 OR, plane polarized light, field of view: 1750 μm across

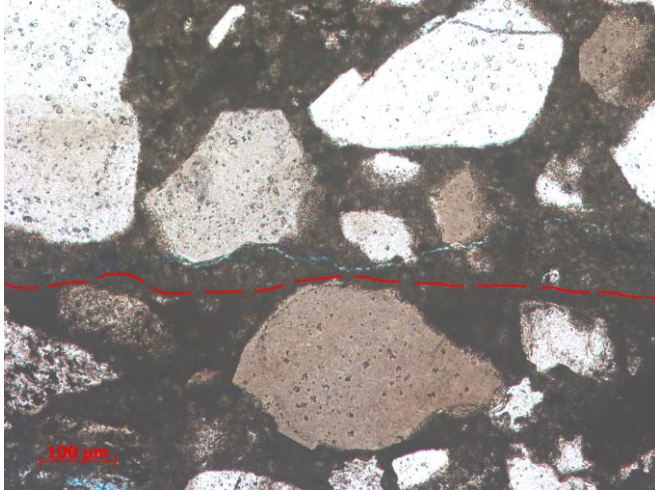
Fig. 5.18. Interface between layers in B25 RR (upper layer in upper half of image, lower layer below), plane polarized light, field of view: 875 μm across

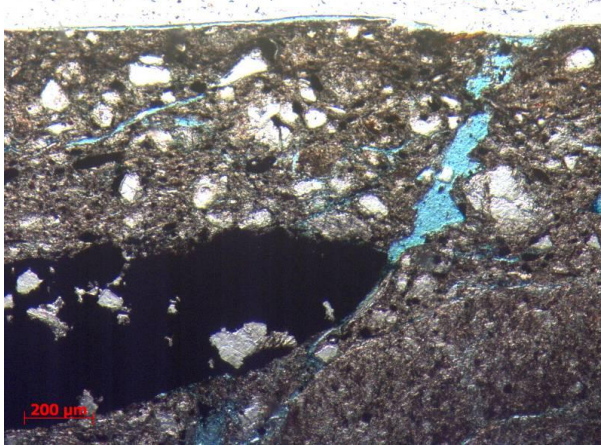
Fig. 5.21. Smooth but cracked surface of the Niddrie brick (surface at top of image), plane polarized light, field of view: 1750 μm across

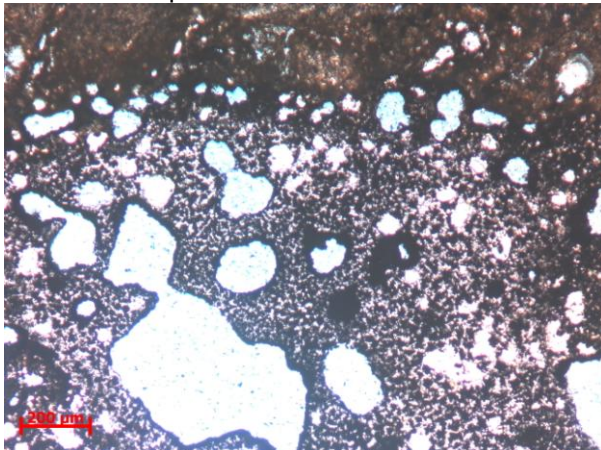
Fig. 5.22. Purple area of high porosity in the Prestongrange brick, plane polarized light, field of view: 1750 μm across

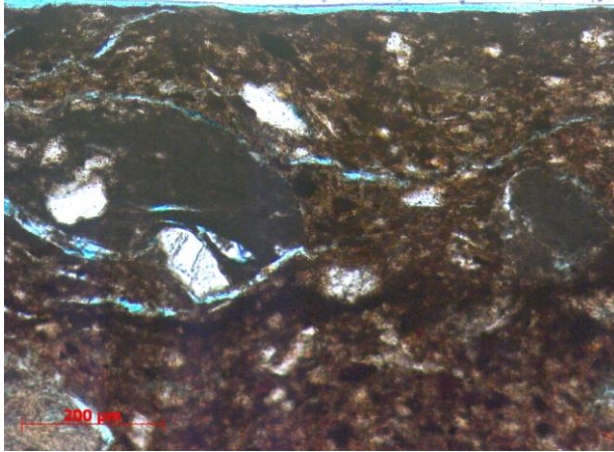
engineering brick, despite this having been specified by NMS. However, the modern brick had a smoother and more compact surface than the historic brick, suggesting it had been well compacted during manufacturing (Fig. 5.23). The fine cracks parallel to the surface may have occurred when the brick was removed from its mould.

Fig. 5.23. Modern brick used to rebuild part of Building 23 in 1992, showing the smooth, compacted surface with fine cracking, plane polarized light, field of view: 1750 μm across

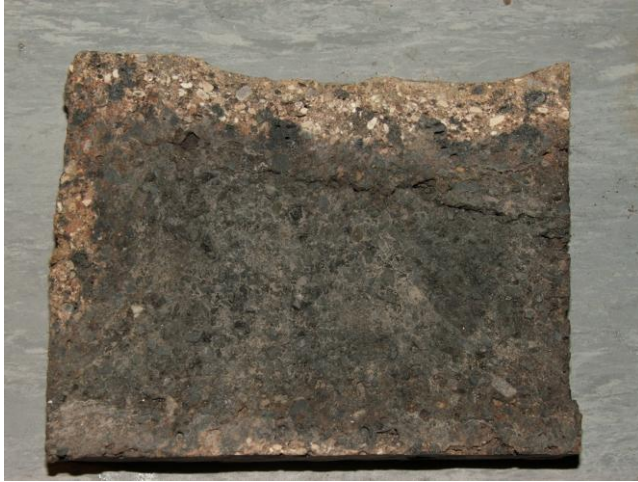
For some of the bricks, different sorptivities were measured depending on whether the core tested was drilled through the bed or stretcher face (Table 7.3). For the Niddrie, Prestongrange and Wallyford bricks, the sorptivity was higher for the stretcher face core than for the bed face core. The difference was greatest for the Prestongrange bricks, and the examination of these bricks without magnification showed cracks running parallel to the bed face (Fig. 7.2), while the thin sections showed the presence of capillary pores up to $70 \mu\text{m}$ long and $10 \mu\text{m}$ wide, again aligned parallel to the bed face (Fig. 7.3). It seems likely that during the sorptivity test water can move more upwards more easily if there are vertical cracks and pores available.

Fig. 7.2. Section through a Prestongrange brick, viewed with the bed faces at the top and bottom, showing large horizontal cracks

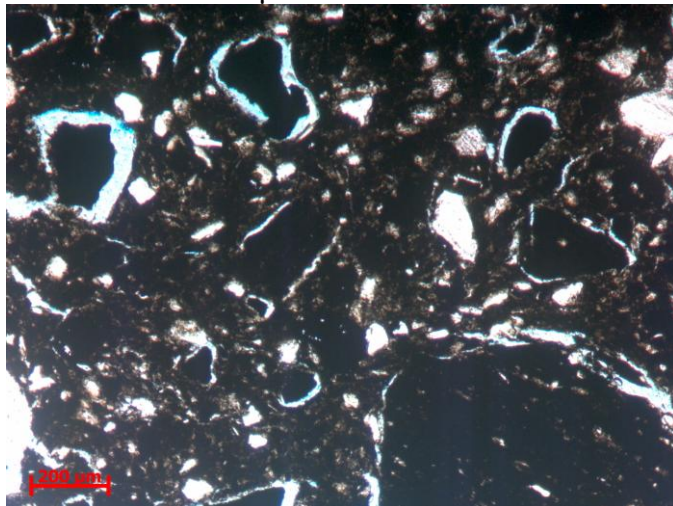
Fig. 7.6. Shrunk mudstone fragments in the Wallyford brick, plane polarized light, field of view: 1750 μm across

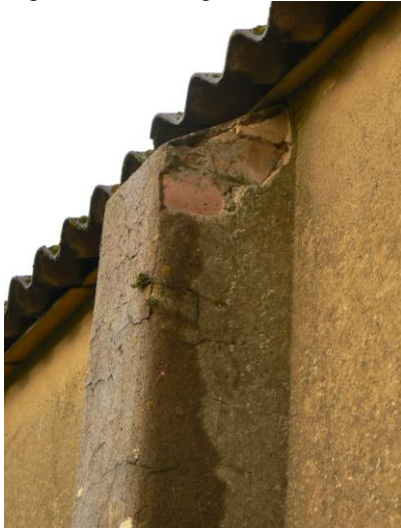
Crack monitoring suggested that the strain between two markers on an area of un-cracked render could vary up to 0.48% over the course of a year, and that the strain between two markers positioned on either side of a crack could vary by up to 1.30%. The stress associated with this amount of strain is calculated in Section 8.3.2.3.

Fig. 8.4. Cracking and render loss on a pier on the SE elevation of Building 38

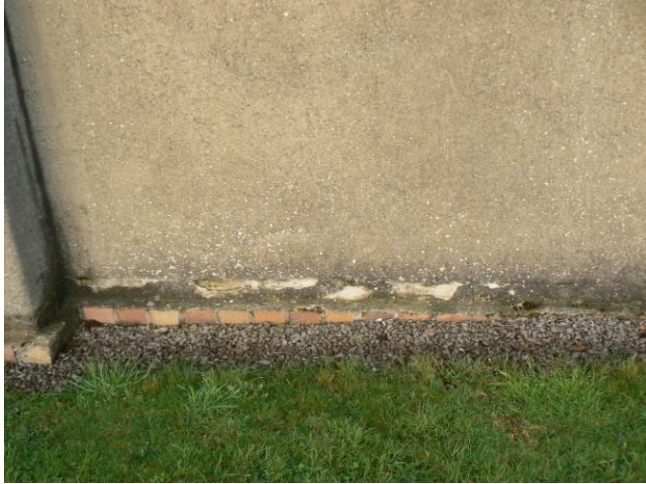
Fig. 8.5. Render loss at the base of the SW elevation on Building 22

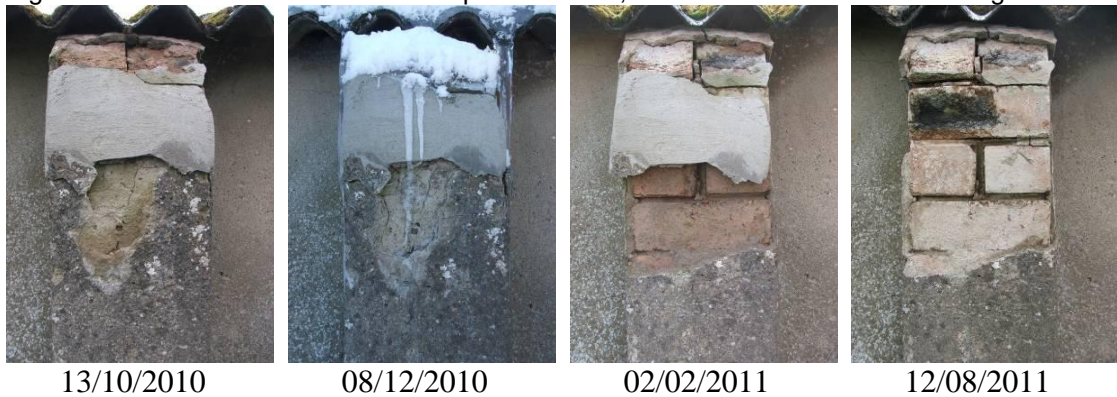
Fig. 8.6. Render losses on the second pier from SW, on the NW elevation of Building 32

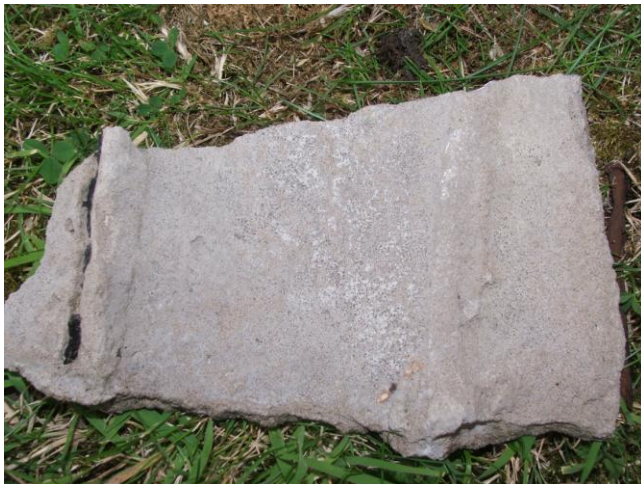
Fig. 8.7. Reverse side of a detached piece of render from Building 22, showing that delamination had occurred at the render-brick interface and only a few small fragments of brick had been removed

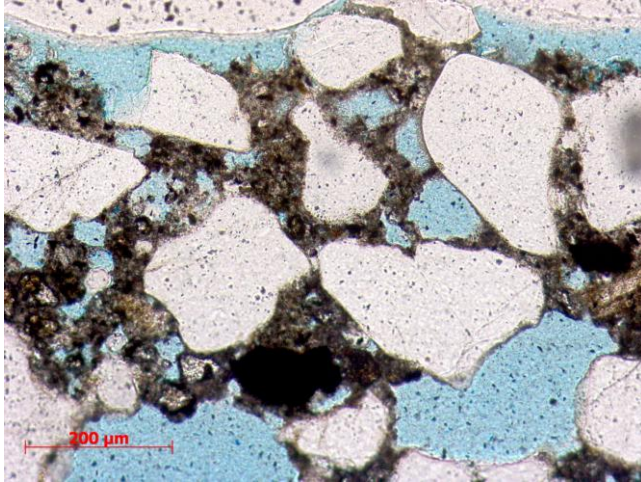
Fig. 8.8. Surface of B24 OR, showing the large, irregular air voids (blue), plane polarized light, field of view: 875 μm across

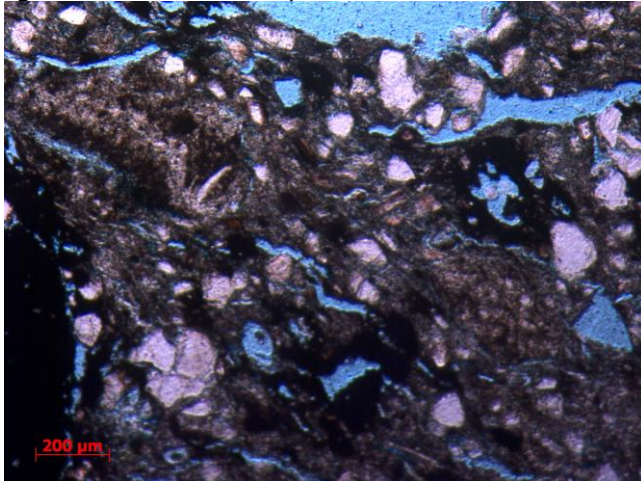
Fig. 8.9. Interior of Niddrie brick, showing the irregular cracks and air voids, plane polarized light, field of view: 1750 μm across

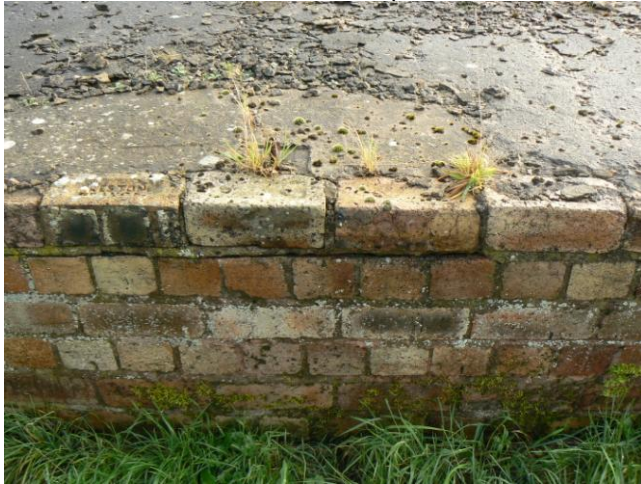
Fig. 8.12. Plinth of Building 33, showing concrete infill with brick exterior. This building was a Nissen hut with curved, corrugated iron walls rather than brick masonry walls, and so was unusual in that the damp proof course was one brick course below the top of the plinth rather than one brick course above the plinth.

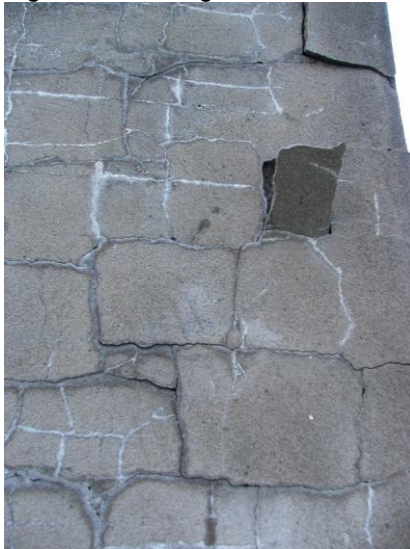
Despite being smoother than the original render and with less exposed aggregate, the repair render applied to Building 23 (B23 RR) was a fairly good colour match for the original, due to the brownish colour of the cement and lichen growth. However, B23 RR had cracked and detached from the brick substrate in large pieces, leaving large expanses of exposed brick. The cracks had often formed over the mortar joints within the brick wall, and there were hard white salt efflorescences along the lines of the cracks, and darkened render to either side of the cracks (Fig. 9.2). It was observed that the render losses increased during periods of freezing weather. Where the repair render had been applied over historic bricks at the bottom of the wall it had also begun to fail, but less dramatically, suggesting that the modern bricks were partly but not wholly responsible for the failure.

Fig. 9.2. Cracking and delamination of the repair render applied to Building 23

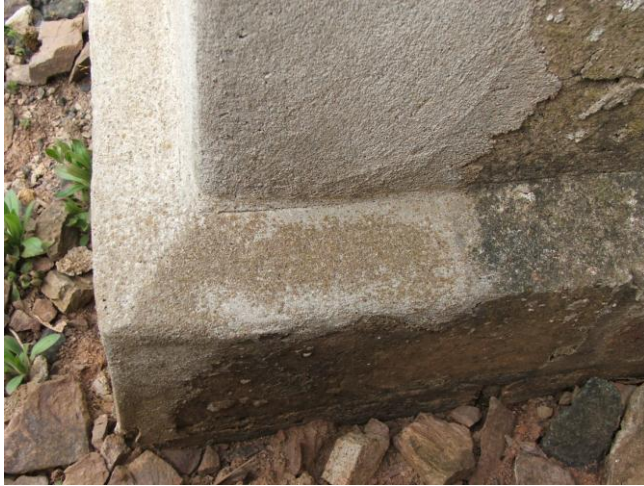
browner as lichen growth accumulated, as had already occurred in frequently wetted areas (Fig. 9.5). Despite the instruction that only failed render should be removed, photographs of the buildings before the work suggested that the repairs had sometimes been more extensive than was strictly necessary, as on the south east face of Building 27 where three of the five bays had been re-rendered entirely (Fig. 9.6).

Fig. 9.5. Colour change due to lichen growth on the post-2000 repairs on Building 25

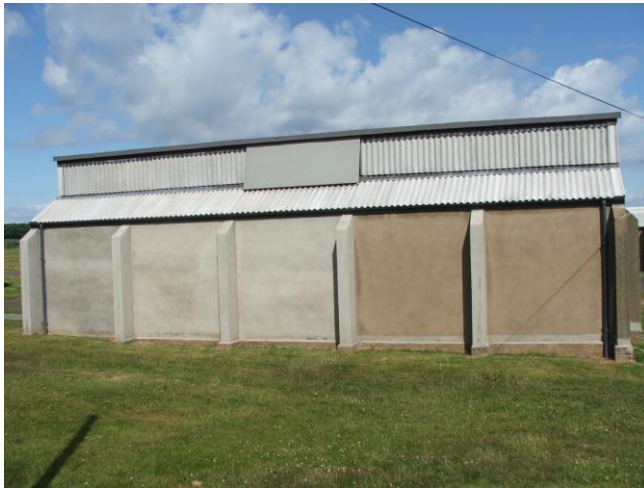
Fig. 9.6. New render on Building 27, showing the extent of the repairs undertaken and also the contrast between old and new

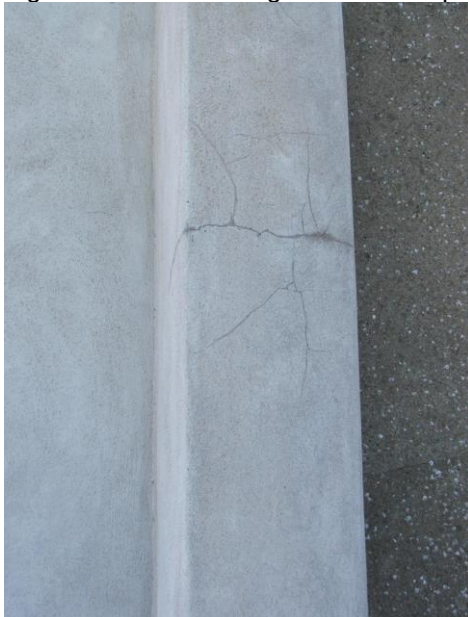
Appearance aside, the post-2000 patch repairs had performed fairly well, with only some minor cracking visible by 2012 (Fig. 9.7). The exception was the free-standing wall running around the loading bay on the south side of Building 25, which had been re-rendered almost entirely in 2005. Here the new render (B25 RR) had cracked extensively (Fig. 9.8), and tapping surveys suggested that it had largely delaminated from the bricks underneath.

Fig. 9.7. Minor cracking of the new repairs

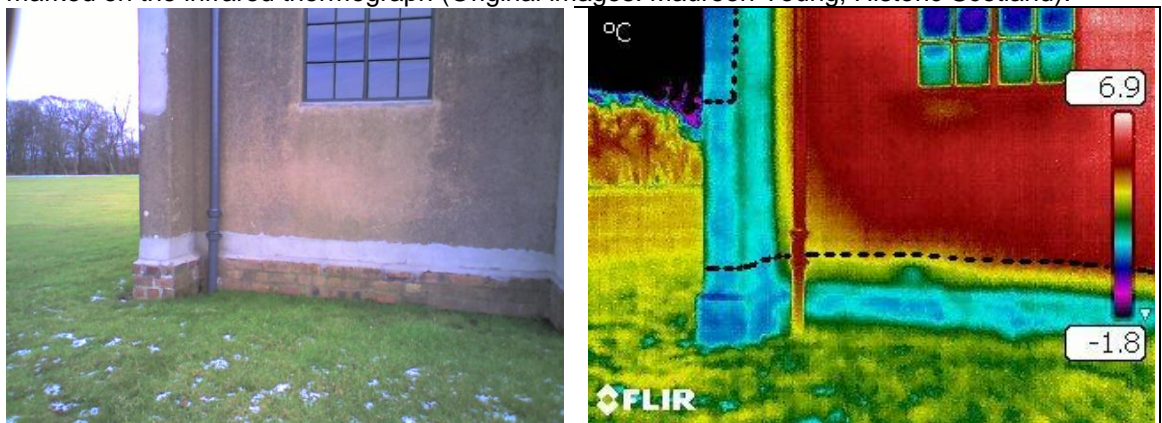
Infrared thermography and electrical resistivity measurements indicated that the moisture content in adjacent areas of original render and post-2000 repair render was very similar, and that there was no build-up of moisture around the edges of the repairs (Fig. 9.10). This suggested that B25 RR had similar hydraulic properties to the original render. It was not possible to compare B23 RR to the original render because they were not applied in adjacent areas.

Fig. 9.10. Infrared thermography in an area on Building 27 with post-2000 repairs, showing no obvious demarcation between the old and new render. The infrared thermograph is a false colour image showing the surface temperature of surfaces in °C, where the red areas are warmest and the purple areas are coolest. The edge of the new repairs has been marked on the infrared thermograph (Original images: Maureen Young, Historic Scotland).

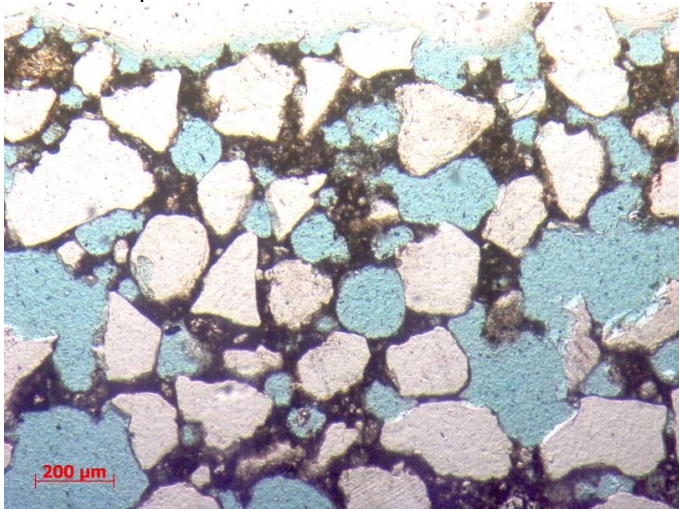
The high porosity of B23 RR was evident in the thin section, and the regular spacing and round shape of the pores suggested the deliberate use of an air-entraining agent (Fig. 9.11). However, the distribution of the voids was too irregular to increase the freeze-thaw durability of the render: the critical spacing factor for air voids in concrete is usually quoted as 200 µm, meaning that the maximum distance between two adjacent voids should be 400 µm [18], but distances of up to 800 µm were measured between adjacent voids in B23 RR. It seemed unlikely that the initial water content had been high because there was very little shrinkage cracking, but the presence of portlandite and calcite in the voids and around the aggregates indicated that there had been a lot of water percolating through the render (Figs. 9.12 and

Fig. 9.11. Extreme porosity near the surface of B23 RR (surface at top of image), with rounded pores suggesting the use of an air-entraining agent, plane polarized light, field of view: 1750 μm across

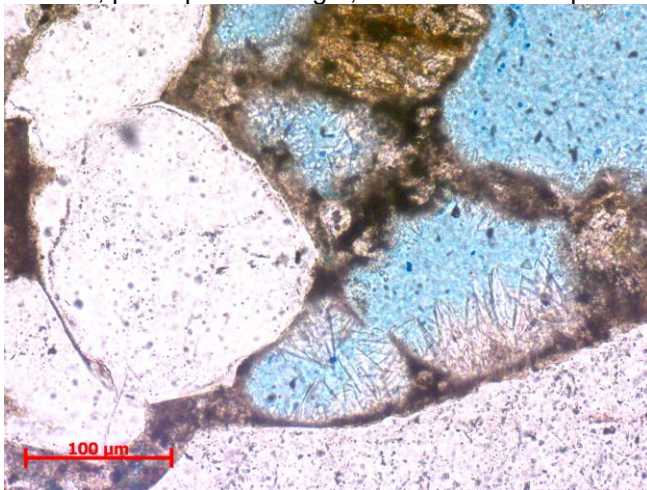
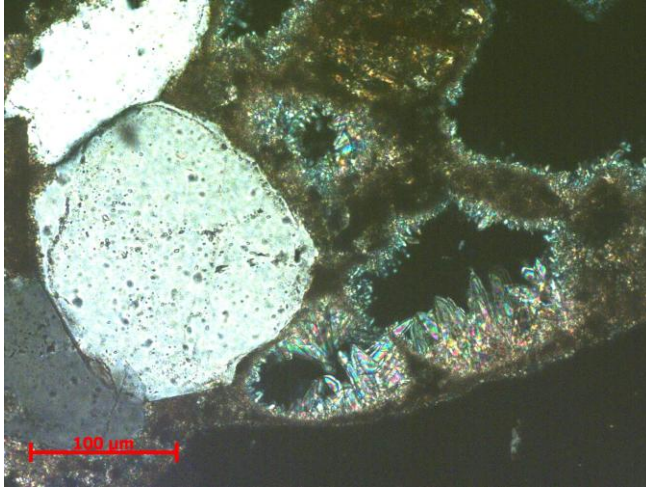
Fig. 9.12. Portlandite and calcite growing in the pores and around the aggregate particles in B23 RR, plane polarized light, field of view: 440 μm across

Fig. 9.13. As above, crossed polars

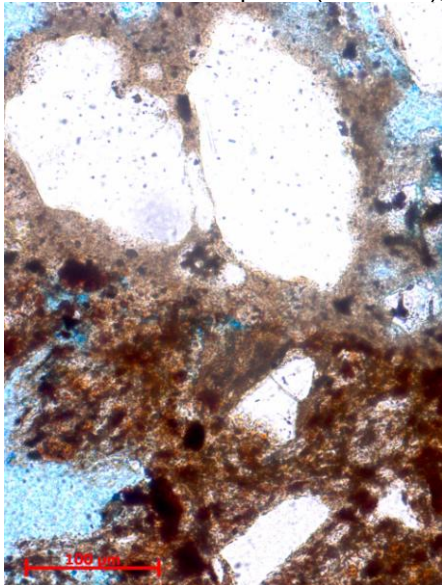
9.13). The render surface along the render-brick interface was plain rather than plucked, indicating that the render had separated easily from the brick. At the only point where a fragment of brick had remained attached to the render there were no portlandite or calcite crystals evident on the brick surface, showing that cement fines had not moved from the render to the brick (Fig. 9.14). This suggested that the brick had not exerted much suction on the render, either because it was over-wetted or of low sorptivity, and that the render-brick bond was poor.

Fig. 9.14. Interface between B23 RR and the brick (render in upper half of image, brick in lower half), showing that there was no portlandite or calcite on either the surface of the brick or inside the brick's pores (lower left), plane polarized light, field of view: 440 µm across
